Cutlery and Allied Trades Research Association

Report No: 956994

Tarnish Testing of Silver Alloys

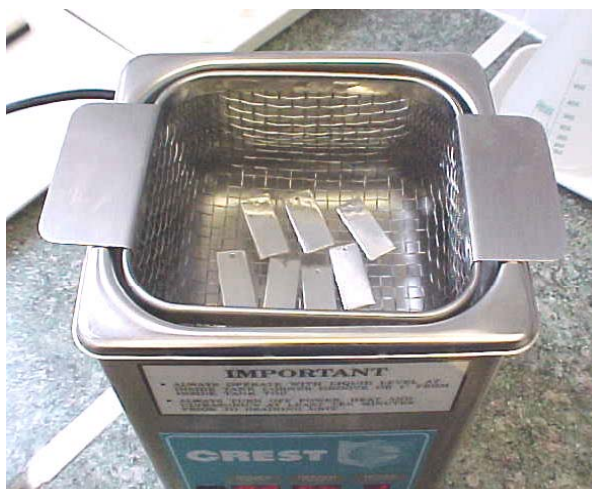
Figure 1
Ultrasonic Solvent Cleaning Bath

The polished surfaces were degreased in an ultrasonic bath using a n-propyl bromide based solvent, *figure 1*.

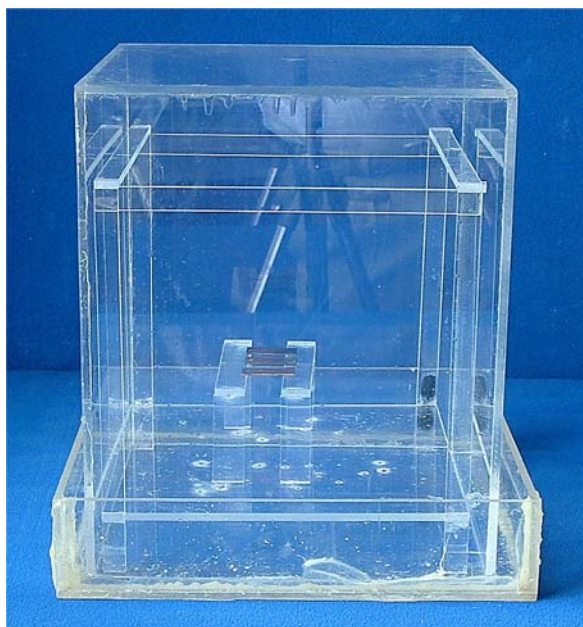
Figure 2
Thioacetamide Test Chamber

BS EN ISO 4538:1995 Thioacetamide corrosion test, *figure 2*, requires the sample to sit in a closed, gas-tight chamber that contains a saturated solution of sodium acetate tri-hydrate and thioacetamide distributed on a horizontal plate within the chamber (50mg per square decimetre of surface). This ensures a relative humidity of 75% at 20 \pm 5°C within the sealed container. The samples sat 65 mm above the plate at an ambient temperature of 24°C.

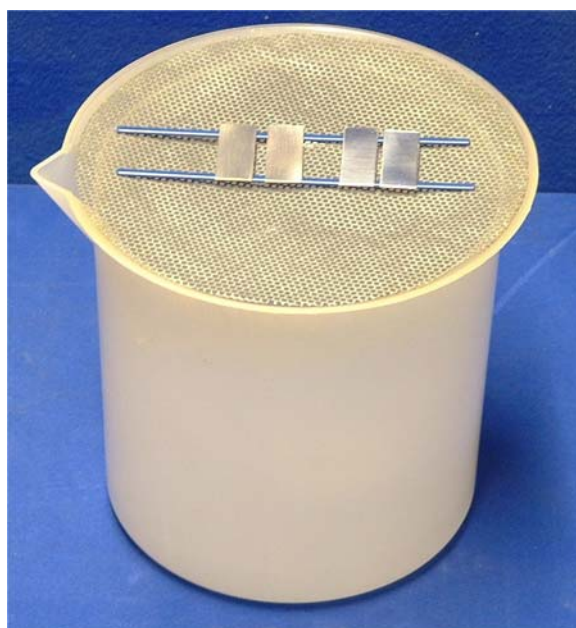
Figure 3
Ammonium Polysulphide Chamber

The ammonium polysulphide laboratory test, *figure 3*, involves suspending the sample on steel mesh above a 5 litre beaker (250 mm high; 200 mm diameter) containing 0.5 mls ammonium polysulphide in 200 mls distilled water.

The apparatus was situated in a fume cupboard with a flow rate of 0.75 m/s and an ambient temperature of 24°C.

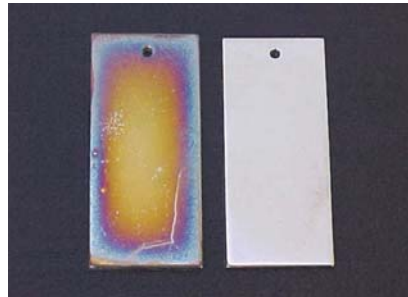
Figure 4

Standard Sterling – left side of each photograph.
Argentium Sterling – right side of each photograph.

BS EN ISO 4538: 1995 Thioacetamide tarnish test – solvent cleaned samples:-

6 hours exposure

The solvent cleaned polished samples were placed in the thioacetamide chamber and observed over a period of 6 hours. The Argentium[®] Sterling did not tarnish whilst the Standard Sterling gradually discoloured over this period.

A photograph showing the degree of tarnish is shown in *figure 4*.

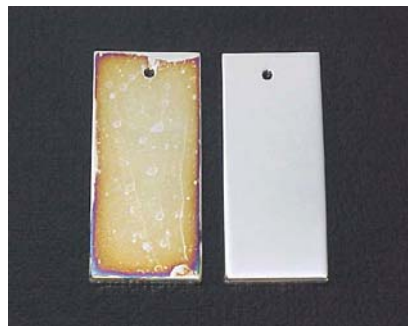
Figure 5a

Dilute Ammonium Polysulphide solution tarnish test – solvent cleaned samples:-

1 hour exposure

The solvent cleaned samples were suspended over the ammonium polysulphide solution and examined after one hour, two hours and 24 hours, *figure 5a,b & c* respectively.

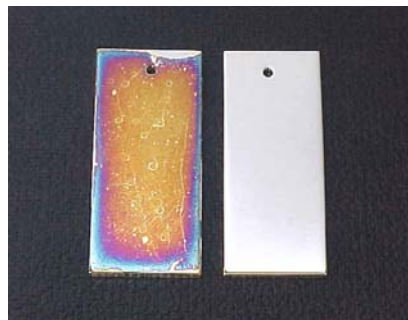
Figure 5b

2 hours exposure

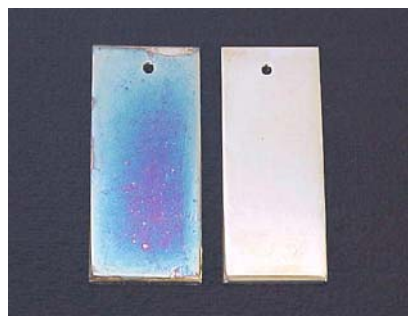
Figure 5c

24 hours exposure

The Argentium[®] Sterling alloy remained tarnish resistant in both the BS EN ISO 4538: 1995 Thioacetamide test, and the dilute Ammonium Polysulphide solution test, compared to the Standard Sterling silver that gradually tarnished with time to become brown or dark blue in colour.
